# Roof Condition Report

07 October 2025

53 Gu\*\*\*\*\* Avenue,  
Surb\*\*\*\*,  
London.  
KT5 \*\*\*

Prepared by: Joe Murtagh

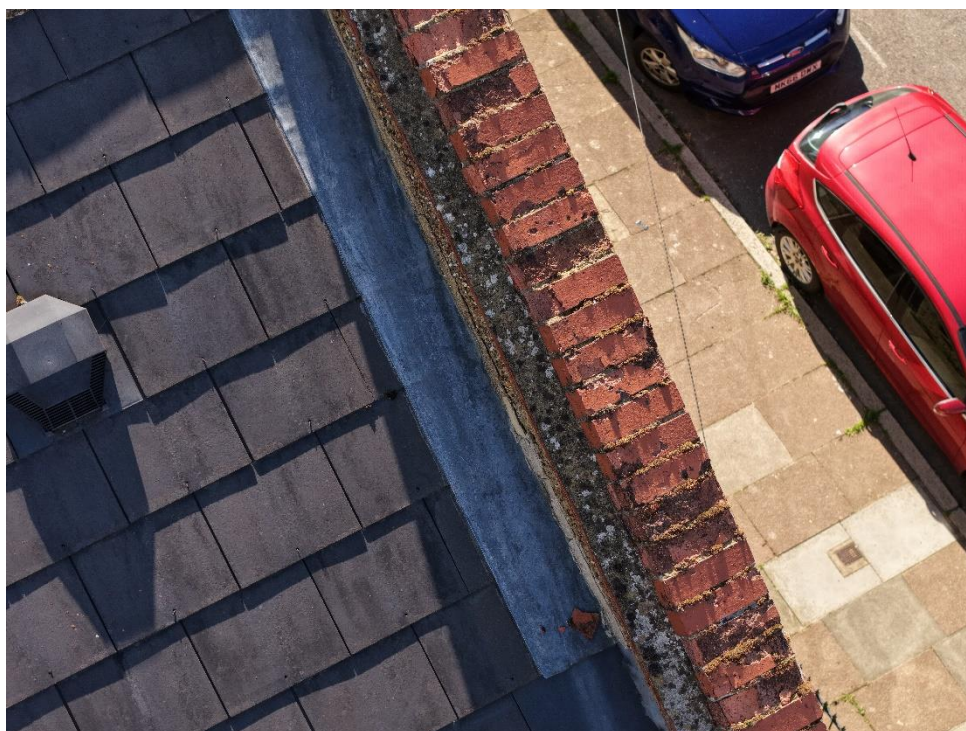
Spalling bricks to front gable (27).

| <i>Issue description</i> | <i>Image number</i> | <i>Recommended Action</i> |
|---|---|---|
| Spalling brick to front Gable (Brick on edge). | 26,27,28 | Re-face or replace damaged bricks |

1. Reface or replace spalling bricks to front gable brick on edge.
2. Refix slates mechanically. (Previously appear to have been stuck with silicone).
3. Install lead flashing to rear gable.
4. Replace Flaunching to both chimneys.
5. Apply patination oil to front Gable lead & check pointing.
6. Repair fiberglass roof to extension.
7. Clean Moss from slates on main roof.
8. Clean Moss from slates to rear addition.

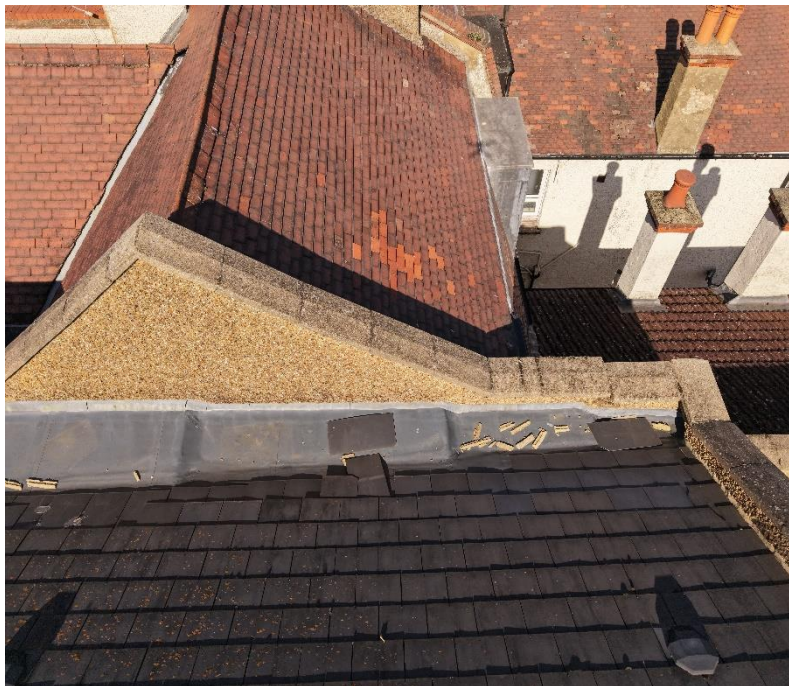
Slates slipped at bottom left (8).

| <i>Issue description</i> | <i>Image number</i> | <i>Recommended Action</i> |
|---|---|---|
| Slates slipped adjacent box gutter. | 7,8,9,10,11,12,13,14,15 | Re-fix loose slates. |

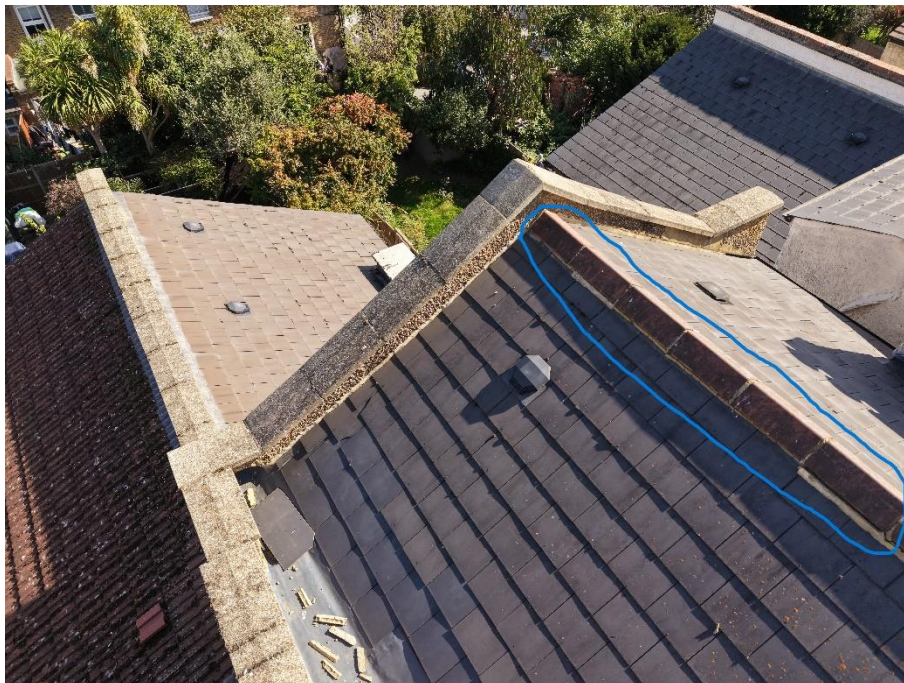
Ridge tile mortar loose (17).

The back chimney requires new Flaunching which is the sharp sand and cement top around the chimney pots. I would make sense to do both at the same time while scaffolding in place. The ridge tiles should be re-bedded and re-pointed as it like this was not repaired properly at the previous attempt.

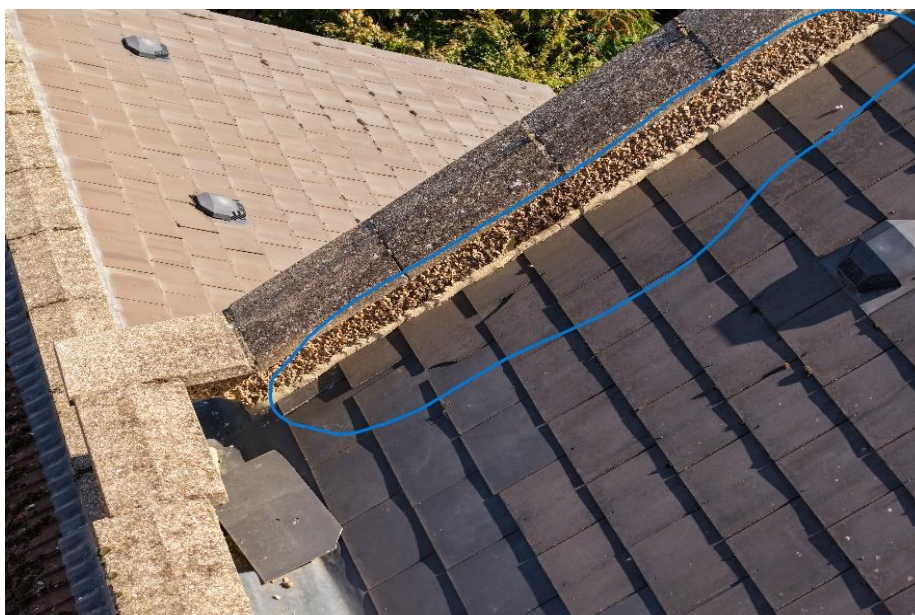
| <i>Issue description</i> | <i>Image number</i> | <i>Recommended Action</i> |
|---|---|---|
| Lead flashing missing. | 19 | Install code 4 lead flashing. |

Lead flashing missing (19).

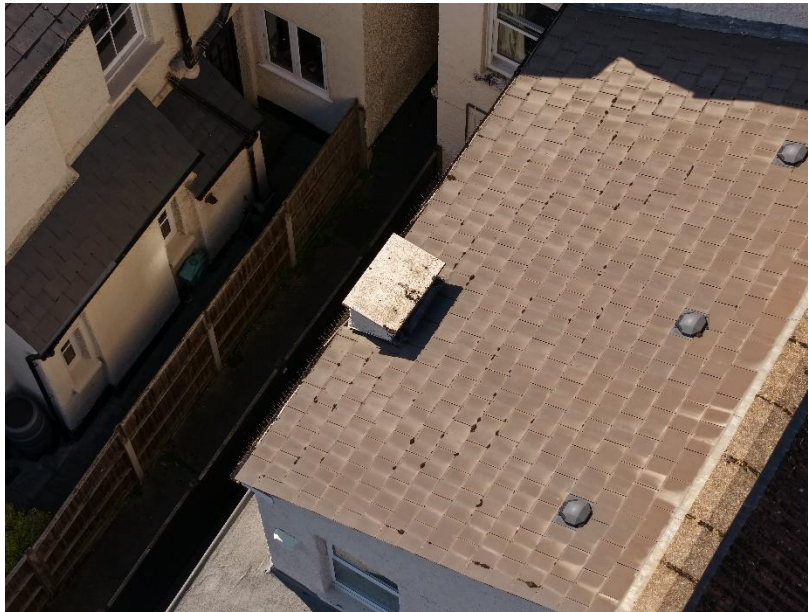
| <i>Issue description</i> | <i>Image number</i> | <i>Recommended Action</i> |
|---|---|---|
| Moss on rear extension roof. (Minor). | 73,74,75,76,77 | Clean moss from slates. |

Moss to rear addition roof (74).

The rear addition roof looks in better condition and just needs the moss cleaning off.

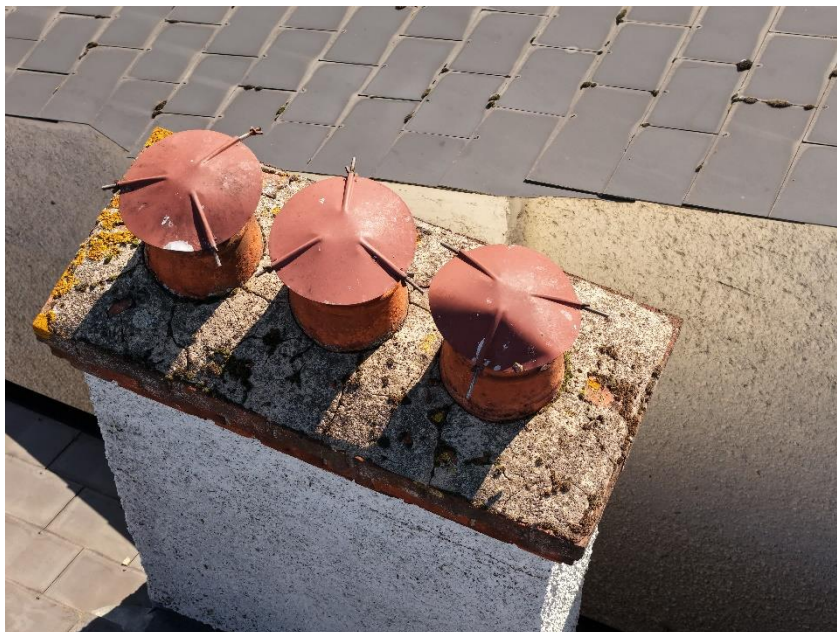
| <i>Issue description</i> | <i>Image number</i> | <i>Recommended Action</i> |
|---|---|---|
| Cracked Flaunching to Chimney. | 46 | Remove & renew loose/cracked Flaunching. |

Cracked flaunching to chimney (46).

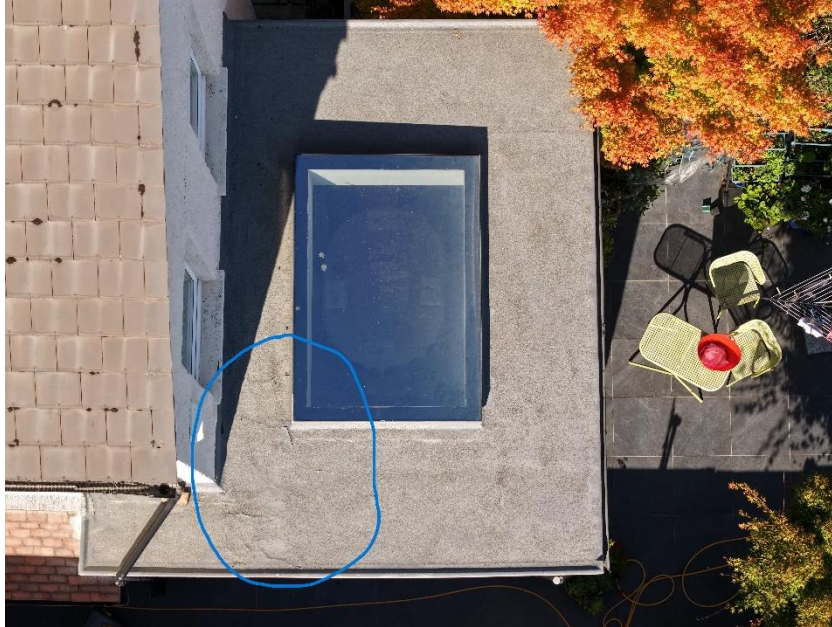
| <i>Issue description</i> | <i>Image number</i> | <i>Recommended Action</i> |
|---|---|---|
| Cracked fiberglass to extension roof. | 58,59 | Repair cracks in fiberglass. |

Cracked fiberglass to extension (58).

The rear extension Fiberglass roof appears to have some cracks and should be investigated further.
