Roof Condition Report (Level 2)

15 January 2026

97Cra***** Road,
Brockley,
London.
SE* **R.

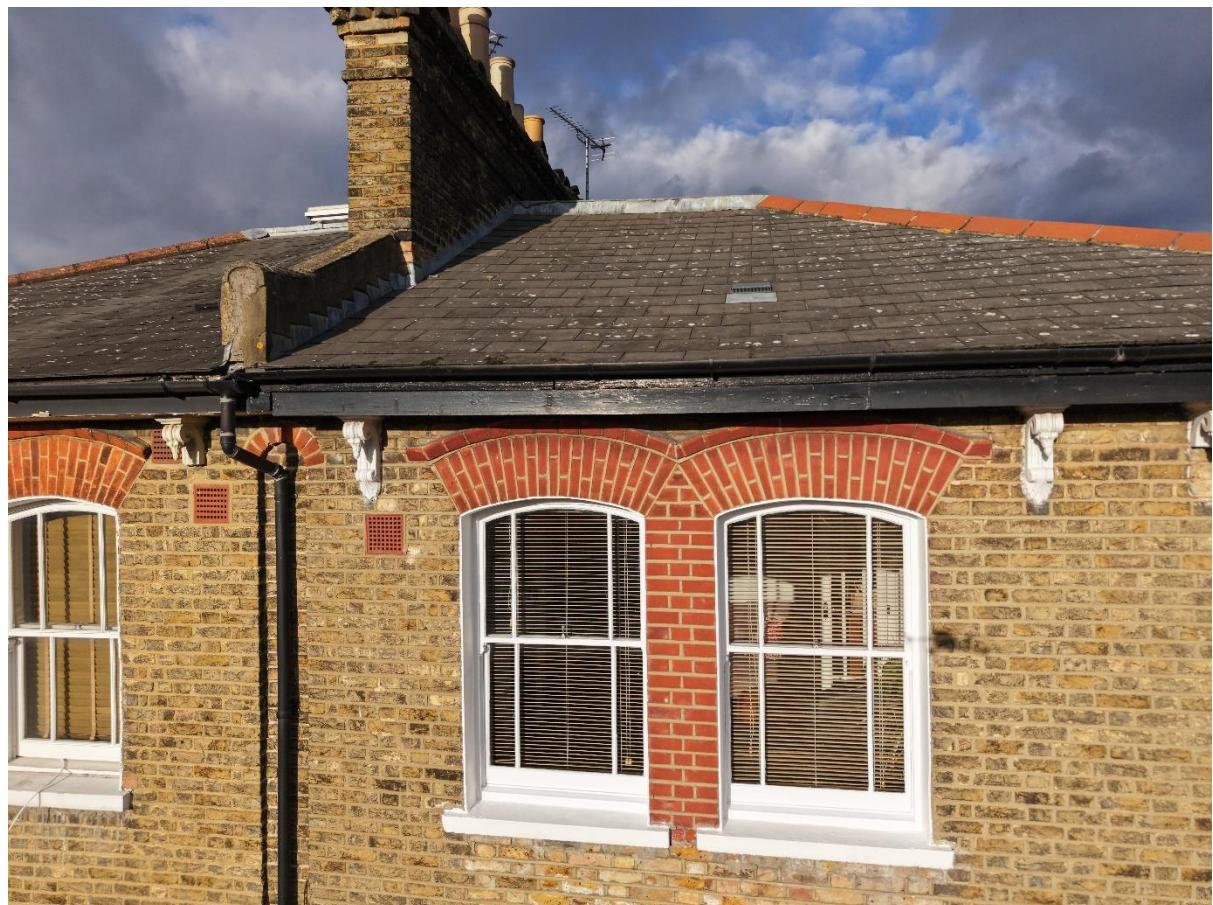
Decorations required to Facia board (42).

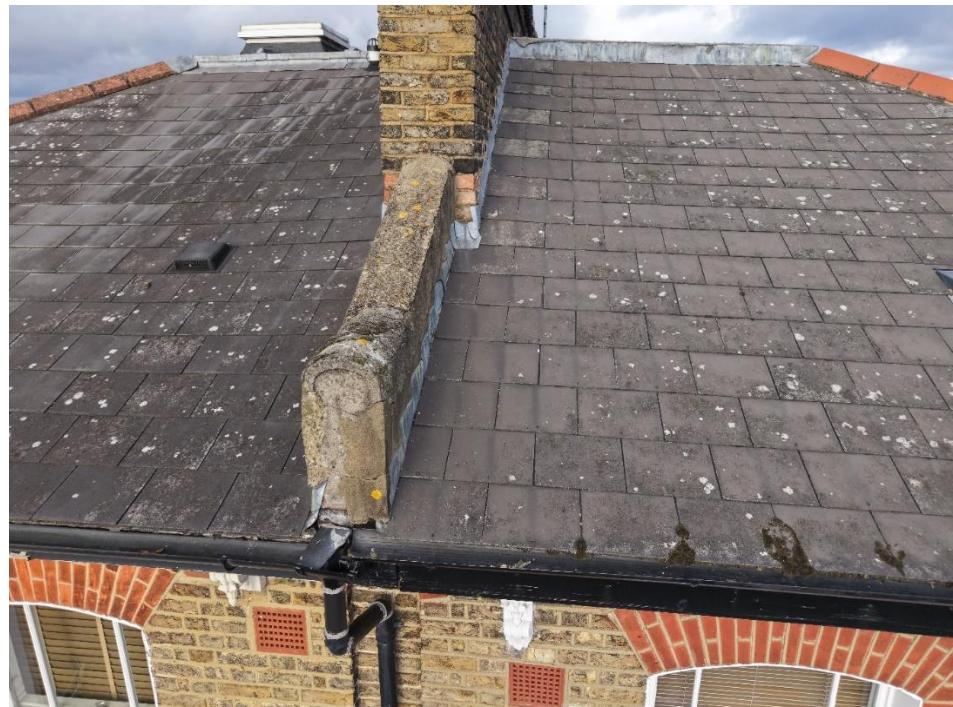
Party Parapet wall cracked render (5).

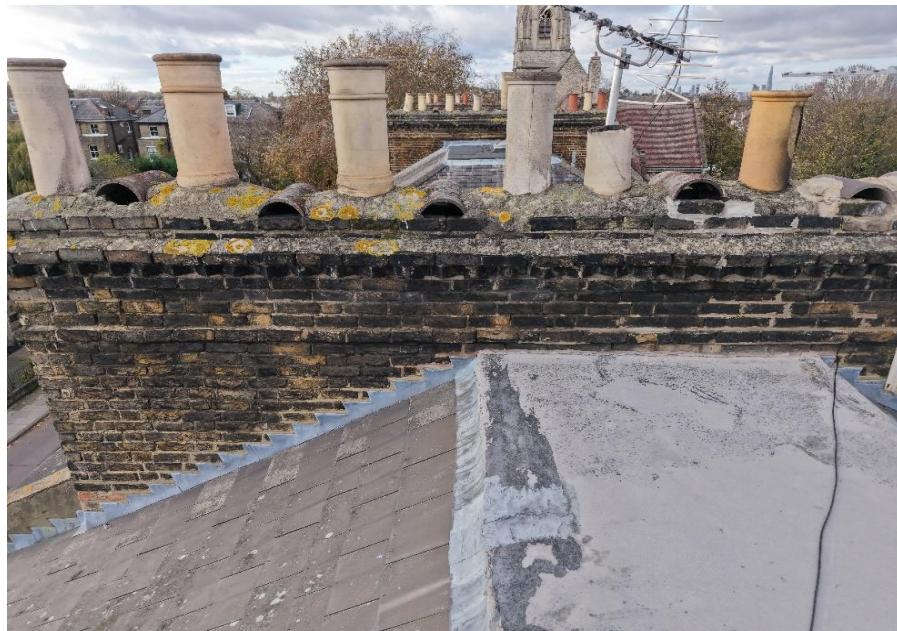
Front L/H Chimney Flaunching Cracked (14).

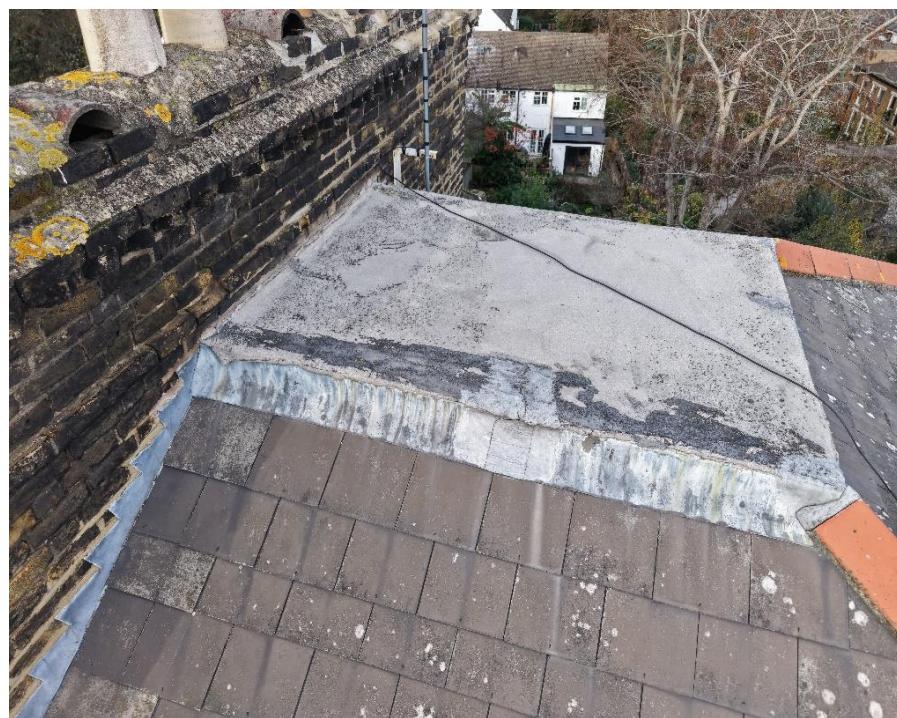
Crack in Asphalt. Flashband Repair to Lead Apron (22).

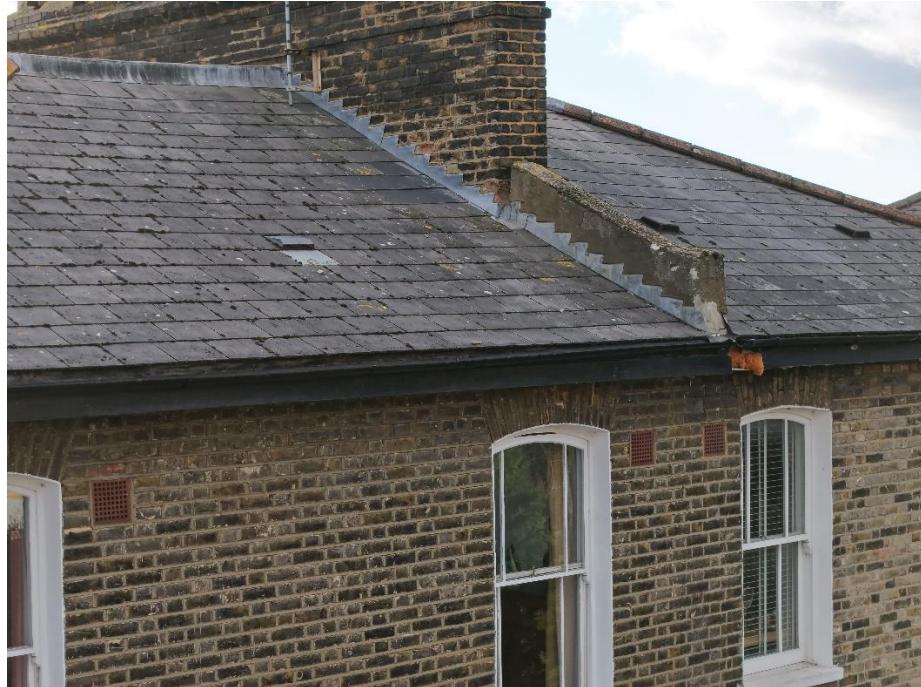
Moss to rear slate roof (48).

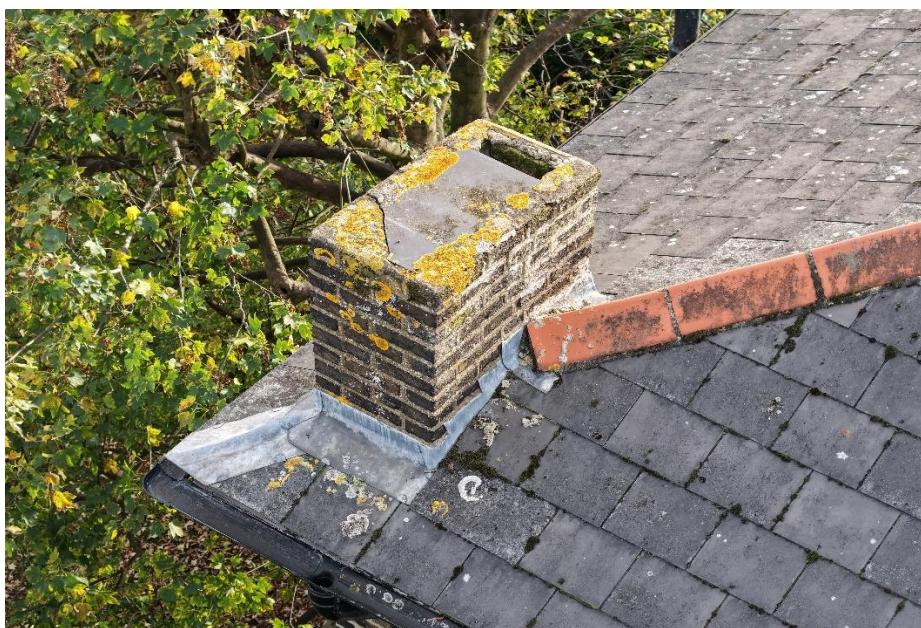
Rear R/H small chimney requires capping off (27)

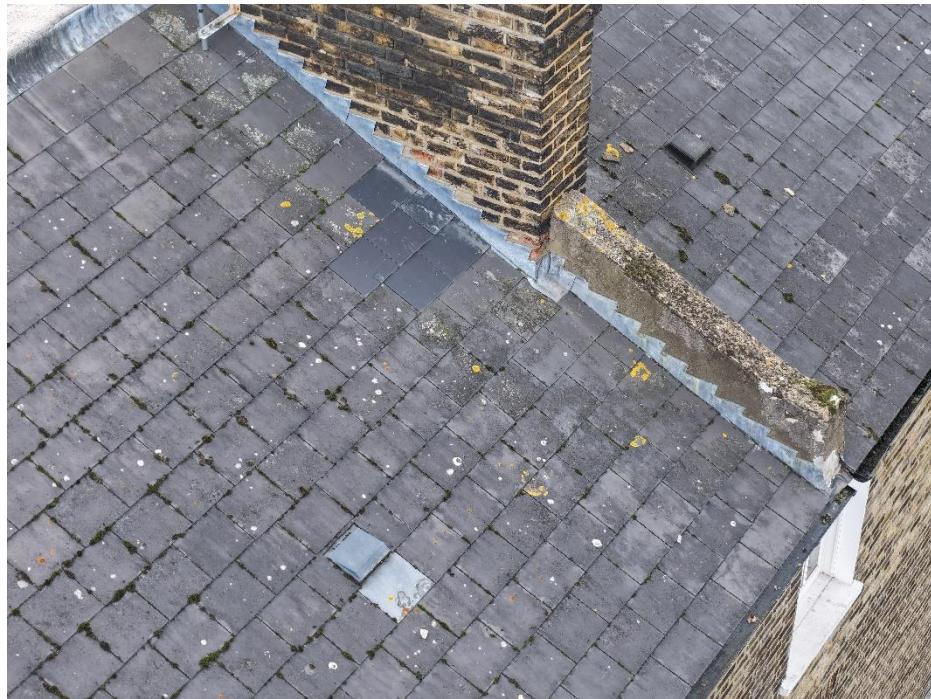
Cracked Render to Rear L/H Party Parapet wall (30).
